**\*\* MANDATORY \*\***  
**SERVICE BULLETIN**

NO.: 0823 Rev B

SUBJECT: GDU 104X CRS/BARO Knob Interference

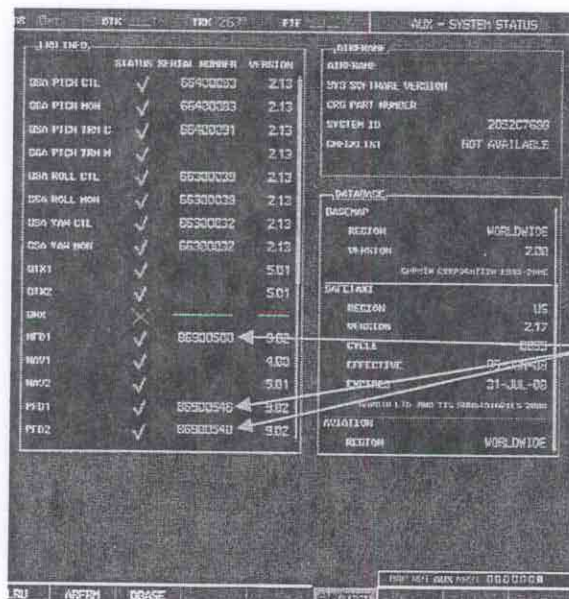
GDU 104X installations with GDU software version 3.02 and later can view unit serial numbers on the AUX – SYSTEM STATUS page. Refer to Figure 2 for an example.

Example  
GDU 104X  
Serial Numbers
